May 12, 2017
Project No. 209914004

Subject: Asbestos Sampling of Roofing Areas Report
Roxbury Park Community Center
471 South Roxbury Drive
Beverly Hills, California

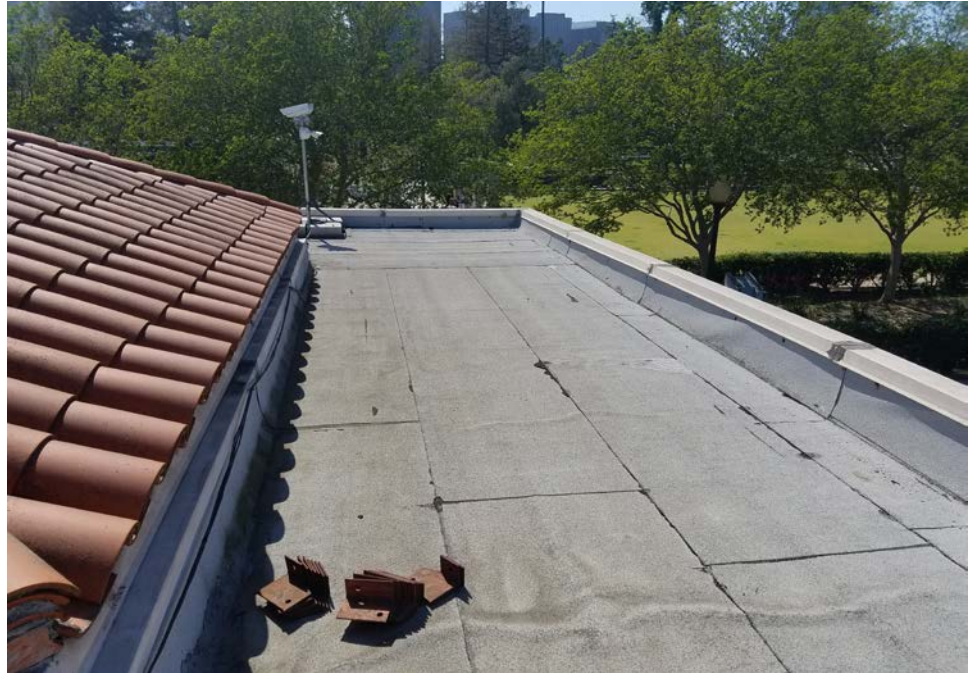
Photograph No. 1: General view of preschool roofing area.

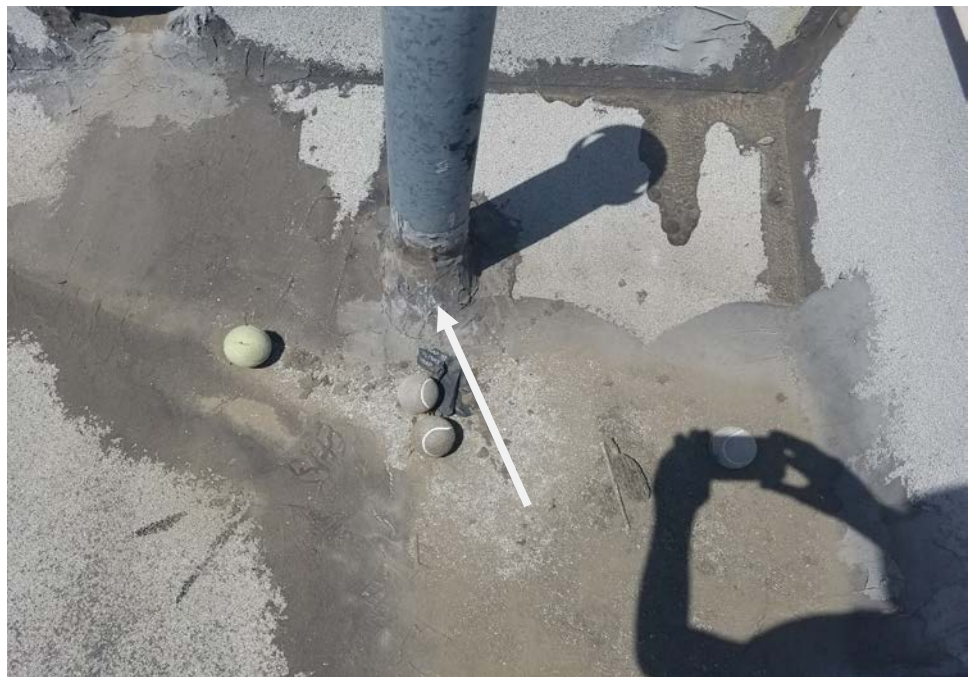
The penetration mastic at the main roofing area and the parapet walls is found to be asbestos containing. General photographic documentation is provided in Attachment C.

Photograph No. 2: View of asbestos containing black penetration mastic at main roofing area.

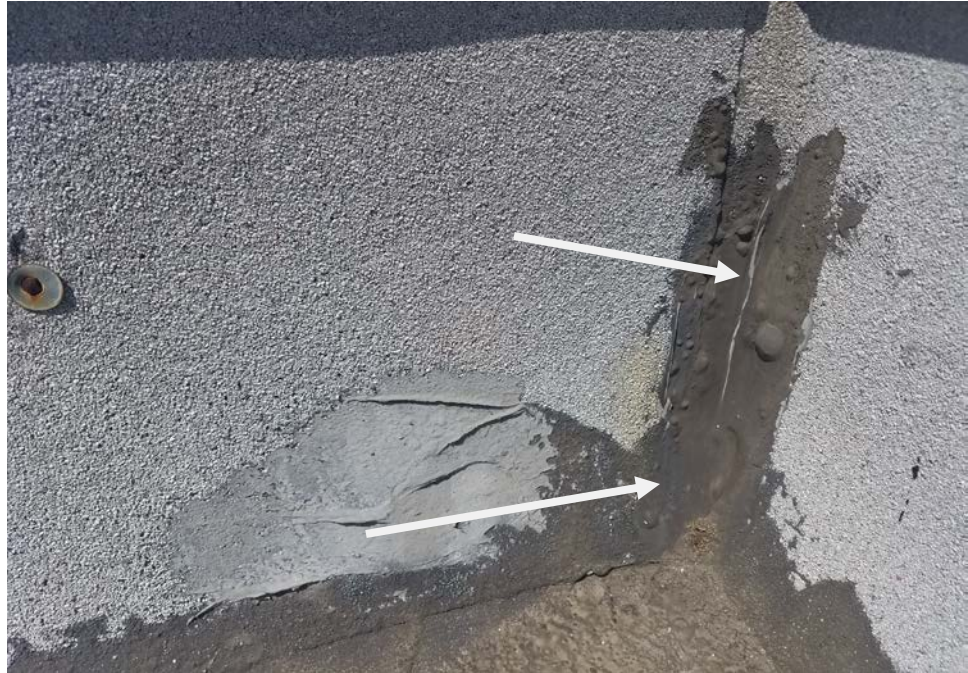
Photograph No. 3: View of gray/black mastic at parapet walls.

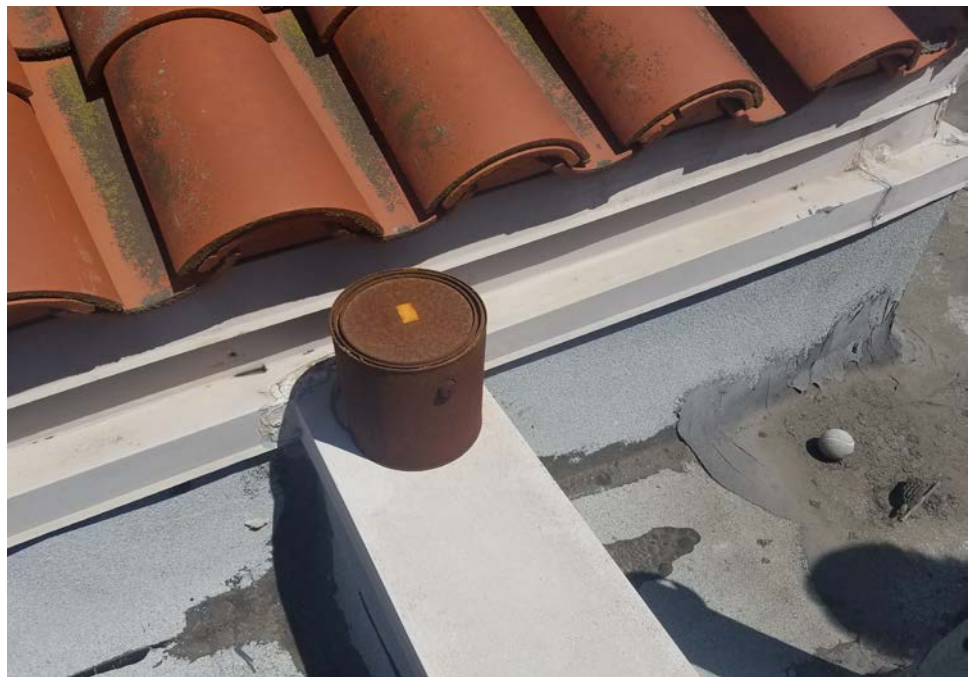
Photograph No. 4: View of assumed asbestos containing can of mastic.
